**Flood Control Project Maintenance
Levee Inspections**

Fall 2016 Levee Maintenance Deficiency Summary Report

**Flood Control Project Maintenance
Levee Inspections**
LMA District Cover Sheet
Fall 2016 Levee Inspection Results

Reclamation District No. 0501 Ryer Island

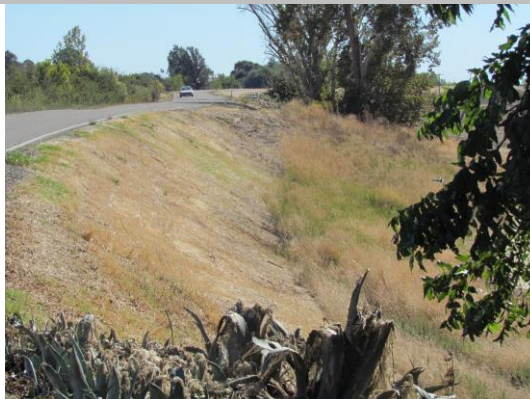
Photo 1 of 1 : FA_2016_RD0501_172_15_20161021_00029.jpg

LM Start	0.00	Rating **	A/W	Issue No.	15
LM End	2.27	Issue Type +	Ma	Location *	LS
Category	Earthen Levee			GPS Latitude/Longitude	
				Start	End
Item	Vegetation			38.285418 °	38.254622 °
				-121.606028 °	-121.601385 °
DWR ID	DWR_RD0501_04_f_2016_15				
Comment Code					
V1 : Control annual grass and weeds on the levee slopes and easements.					
Inspector Comment					
RD is in process of mowing the landside slope working downstream.

RD 501 Unit 4 looking downstream from levee mile 0.00- 2.27 landside slope.

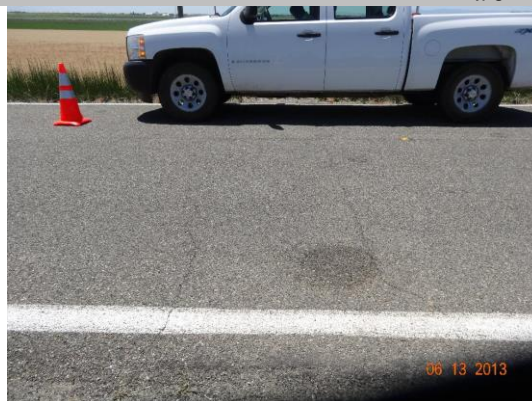
Photo 1 of 2 : UCIP_FA_2016_32547_59050.jpg

FS_ID:32547
DS_ID:21080
EP_NO: 18135
Repair Type: Non-Urgent
Crossing Status: Found
UCIP Comments: Cracks visible on levee crown could be associated with pipe vibration or settlement. Burrow activity on landward side. Recommend removing vegetation along pipe alignment on landward side to conduct proper inspection of structure and appurtenances.
FIELD_STRUCT_DESC: 10-inch iron pipe through the levee, 3.5 feet below the crown. Cutoff wall around pipe at landward shoulder. Slant pump and pump house on waterward slope. Concrete standpipe and power pole at landward toe. Service pole on landward slope. Pipe exposed on both slopes. (Permit No. 2446-1957) Section of pipe under levee crown, between both shoulders, was removed and replaced with a 10-inch steel pipe under Permit No. 18135 (2006). Two crossings nearby 10-inch pipe and 8-inch pipe crossings are approximately 5 feet apart.
FS Date: 6/7/2013

View of levee crown.

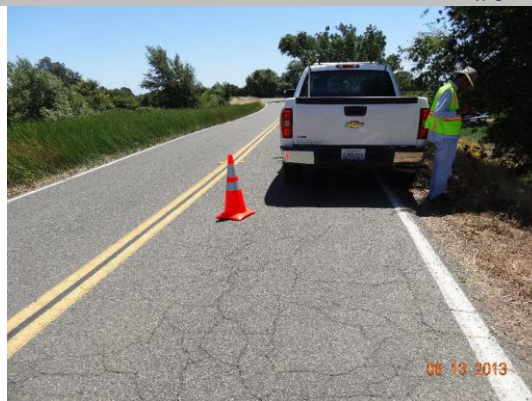
Photo 1 of 2 : UCIP_FA_2016_50021_59065.jpg

FS_ID:50021
DS_ID:21072
EP_NO: N/A
Repair Type: Urgent
Crossing Status: Found
UCIP Comments: 8/22/2016 Assume conditions at this crossing have remained the same--pipe wall is still deteriorating. Unable to locate crossing due to dense vegetation along both WS and LS slopes. Recommend removing vegetation along pipe alignment to conduct proper inspection of structure and appurtenances. (DWR UCIP - omagana)6/13/2013 Pipe has deteriorated--holes present on landward side. Need to contact owner. Unable to determine if crossing is still being used. Dense vegetation limits the inspector's visibility to identify signs of pipe failure (leaks) along the waterward slope. Recommend removing vegetation along pipe alignment to conduct proper inspection of structure and appurtenances. (DWR UCIP - omagana)
FIELD_STRUCT_DESC: *ABANDONED* 8-inch irrigation steel pipe through the levee, 2.7 feet below the crown. Pump is located on waterside (WS). Steel plate welded on WS end unable to confirm if plate is still present 2016. [Additional Reference(s): DWR Levee Log, 2005. USACE Sacramento O&M Manual Unit No. 105, April 1959, (HLM 1.10)].

View of levee crown at crossing.

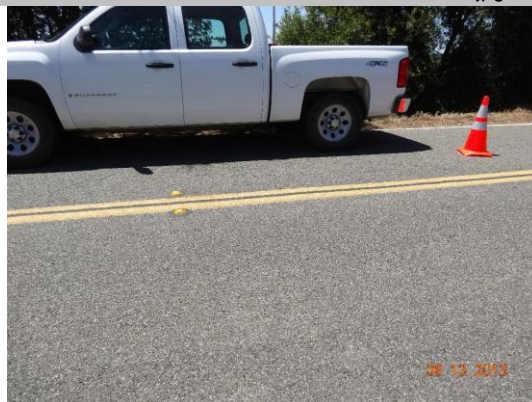
Photo 2 of 2 : UCIP_FA_2016_50021_59066.jpg

View of levee crown at crossing.

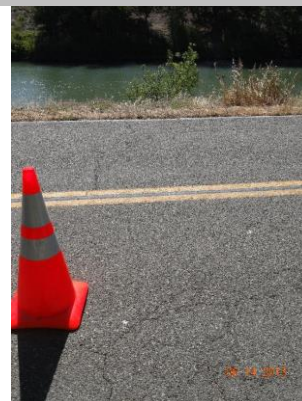
Photo 1 of 2 : UCIP_FA_2016_32550_59068.jpg

LM Start	1.08	Rating **	M	Issue No.	20
LM End	1.08	Issue Type +	En	Location *	WS
Category	Supplemental			GPS Latitude/Longitude	
				Start	End
Item	DWR UCIP Field Study			38.271400 °	38.271400 °
				-121.604368 °	-121.604368 °
DWR ID					
Comment Code					
Inspector Comment					
FS_ID:32550 DS_ID:21073 EP_NO: N/A Repair Type: Non-Urgent Crossing Status: Indicator Found UCIP Comments: Unable to determine if the pipe goes through the levee. need As-Built drawings; Need owner information. FIELD_STRUCT_DESC: 1.5-inch conduit through the levee, 2.0 feet below the crown. Pole and anchor on landward slope. FS Date: 6/13/2013

Levee crown at crossing.

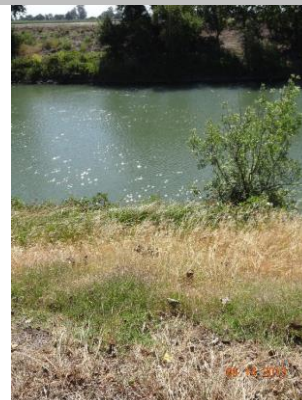
Photo 2 of 2 : UCIP_FA_2016_32550_59067.jpg

View of waterward side.

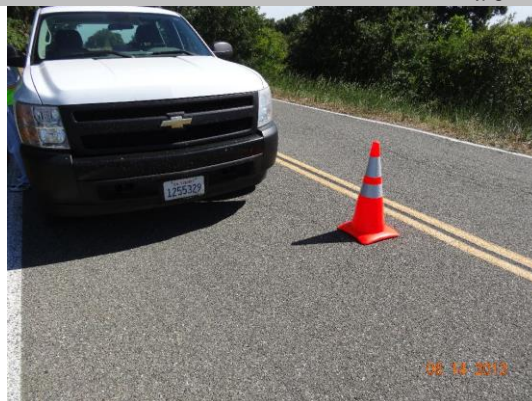
Photo 1 of 2 : UCIP_FA_2016_32551_59070.jpg

FS_ID:32551
DS_ID:21074
EP_NO: N/A
Repair Type: Non-Urgent
Crossing Status: Found
UCIP Comments: Unable to determine status of crossing. Pipe visible on waterward side--could be the pipe that was supposed to be removed under permit number 13983 (1985). Also present is a 1.5 inch conduit along the 8 inch pipe. Need to coordinate with owner.
FIELD_STRUCT_DESC: 8-inch steel pipe through the levee, 6.4 feet below the crown. Pump on pile structure in stream. Service pole on landward slope. (USACE-1959). This entry matches the Drainage or Irrigation Structure referenced in O&M manual (HLM 1.30). Pipe should have been removed and replaced with 12-inch pipe under Permit No. 13983 (1985).
FS Date: 6/13/2013

View of levee crown at crossing.

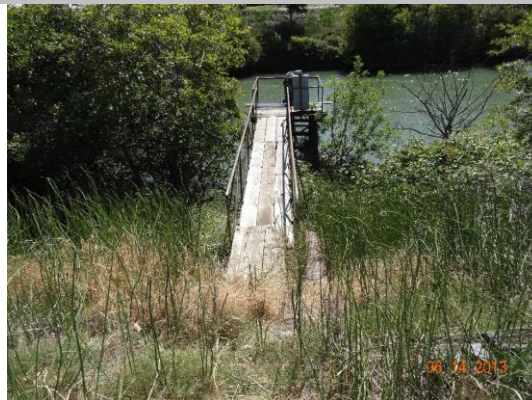
Photo 2 of 2 : UCIP_FA_2016_32552_59076.jpg

FS_ID:32552
DS_ID:21095
EP_NO: 13983
Repair Type: Non-Urgent
Crossing Status: Found
UCIP Comments: Abandoned pipe was to be removed during the installation of new 12-inch pipe crossing. Need to contact pipe owner. Unable to confirm crossing--need additional records for crossing.
FIELD_STRUCT_DESC: 12-inch steel pipe through the levee, 5.0 feet below the crown. Cutoff wall around pipe at center of levee. Siphon breaker on apex of pipe at landward shoulder. Pump on pile structure in stream. Service pole on landward slope. Pipe connects to 10-inch steel pipe along the landward slope at the shoulder, and similarly to pre-existing 8-inch pipe on the waterward side. (Permit No. 13983-1985)
FS Date: 6/13/2013

View of waterward side--walkway, pump, conduit, and pipe.

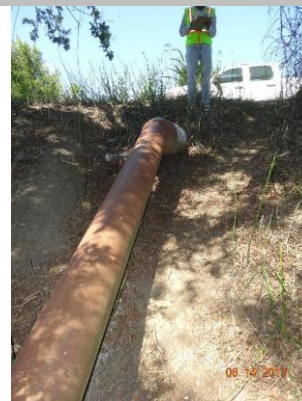
Photo 1 of 2 : UCIP_FA_2016_44471_33491.jpg

Comment Code					
Inspector Comment					
FS_ID:44471					
DS_ID:21076					
EP_NO: 16906					
Repair Type: Non-Urgent					
Crossing Status: Found					
UCIP Comments: Crossing was running during site inspection. Dense vegetation limits the inspector's visibility to identify signs of pipe failure (leaks) along the landward slope. Recommend removing vegetation along pipe alignment to conduct proper inspection of structure and appurtenances.					
FIELD_STRUCT_DESC: 14-inch steel pipe through the levee, 2.2 feet below the crown. Pump on pile structure in stream. Concrete standpipe on landward side. Pipe is exposed on landward slope. (Permit No. 16906-1999) Two conduits present 3 inch conduit disconnected and 1.5 inch electrical conduit appears to be active.					
FS Date: 6/13/2013

Waterward side-pipe along slope.

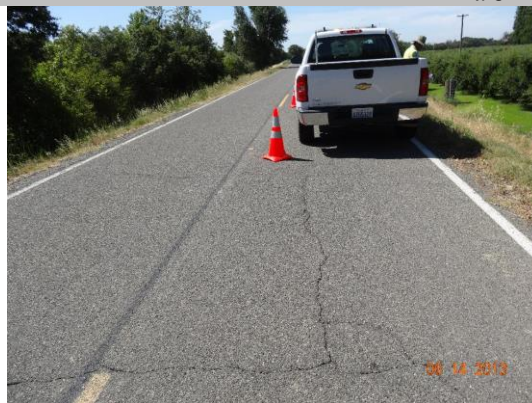
Photo 1 of 2 : UCIP_FA_2016_32553_59082.jpg

Comment Code					
Inspector Comment					
FS_ID:32553					
DS_ID:21077					
EP_NO: N/A					
Repair Type: Non-Urgent					
Crossing Status: Found					
UCIP Comments: Dense vegetation limits the inspector's visibility to identify signs of pipe failure (leaks) along the waterward and landward slope. Recommend removing vegetation along pipe alignment to conduct proper inspection of structure and appurtenances.					
FIELD_STRUCT_DESC: 14-inch steel pipe through the levee, 8.0 feet below the crown. 2 inch conduit goes through levee. Siphon breaker on landward slope. Pump on pile structure in stream. (USACE-1959). This entry matches the Drainage or Irrigation Structure referenced in O&M manual (HLM 2.0).					
FS Date: 6/13/2013

View of levee crown at crossing.

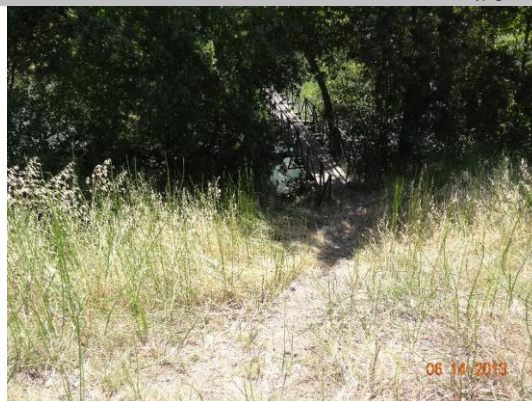
Photo 2 of 2 : UCIP_FA_2016_32553_59081.jpg

Comment Code					
Inspector Comment					
FS_ID:32553 DS_ID:21077 EP_NO: N/A Repair Type: Non-Urgent Crossing Status: Found UCIP Comments: Dense vegetation limits the inspector's visibility to identify signs of pipe failure (leaks) along the waterward and landward slope. Recommend removing vegetation along pipe alignment to conduct proper inspection of structure and appurtenances. FIELD_STRUCT_DESC: 14-inch steel pipe through the levee, 8.0 feet below the crown. 2 inch conduit goes through levee. Siphon breaker on landward slope. Pump on pile structure in stream. (USACE-1959). This entry matches the Drainage or Irrigation Structure referenced in O&M manual (HLM 2.0). FS Date: 6/13/2013

View of waterward side.

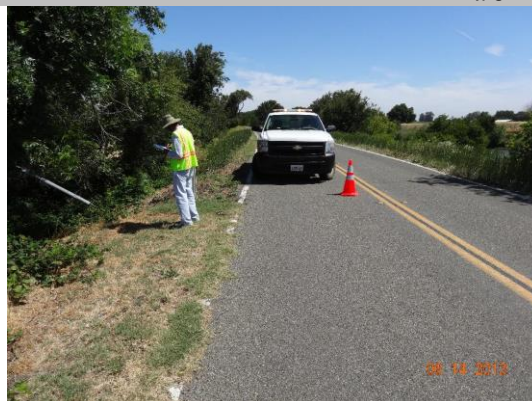
Photo 1 of 2 : UCIP_FA_2016_32863_59483.jpg

FS_ID:32863
DS_ID:21078
EP_NO: N/A
Repair Type: Non-Urgent
Crossing Status: Found
UCIP Comments: Broken concrete box on landward slope. Disturbed soil on waterward slope--unable to determine section disturbed. Dense vegetation limits the inspector's visibility to identify signs of pipe failure (leaks) along the waterwar slope. Recommend removing vegetation along pipe alignment to conduct proper inspection of structure and appurtenances.
FIELD_STRUCT_DESC: *ABANDONED* 6-inch and working 6-inch steel pipes through the levee, 2.5 and 5.0 feet below the crown, respectively. 1.5 inch electrical conduit through levee. Pump in pump house on waterward slope. (USACE-1959). This entry matches the Drainage or Irrigation Structure referenced in O&M manual (HLM 2.30). Pipes are within 5 feet.
FS Date: 6/13/2013

View of levee crown at crossing.
